MIRROR LAKE

LAKE BIOASSESSMENTS

November & December 2014; March 2015

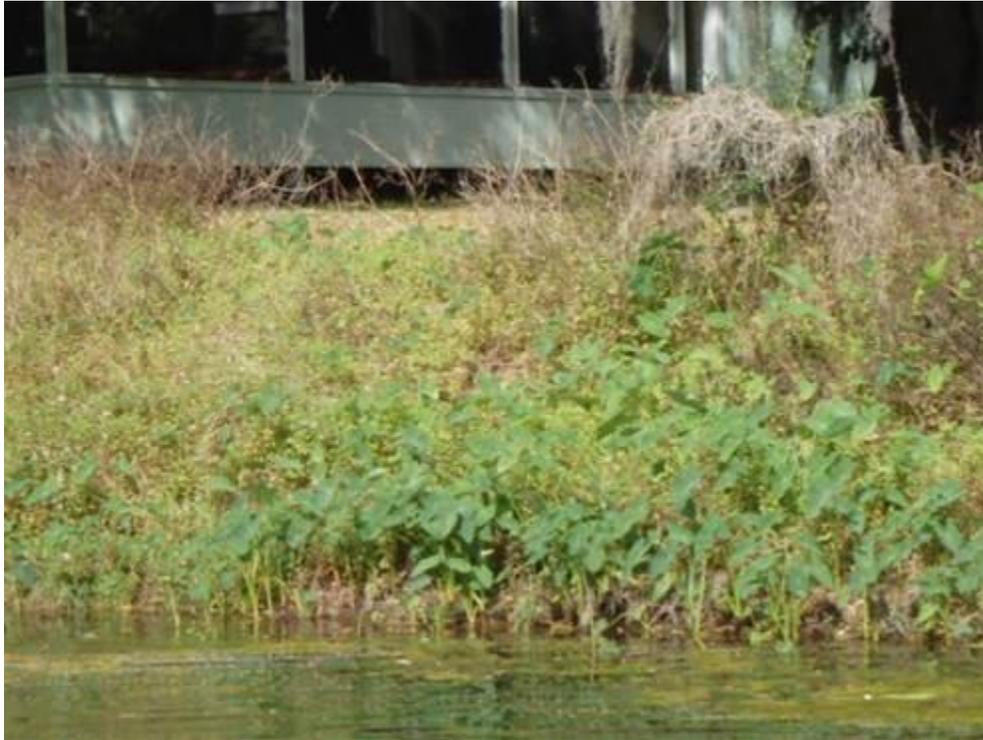
Invasive emergent vegetation included: alligatorweed, wild taro, torpedo grass, wedelia, and cattail. No American lotus was present as in previous months. Cattail is coming back and will be targeted during the next herbicide treatment. Access corridors throughout the lake are open and navigable.

Photo: Wild taro (invasive)

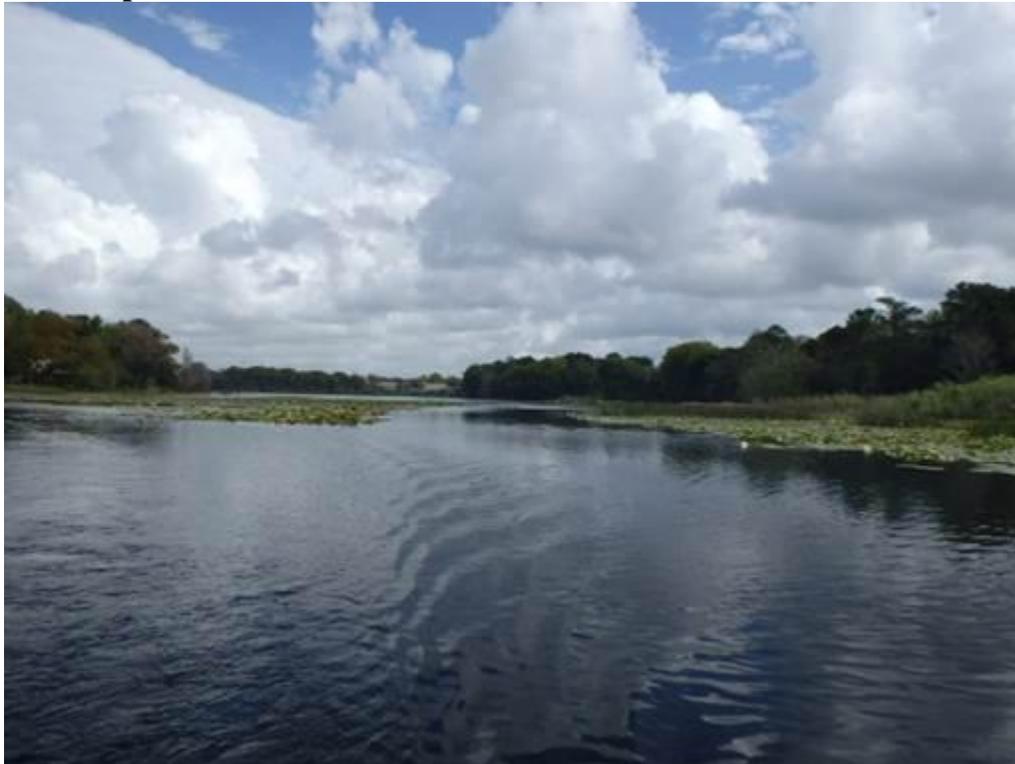
Photo: Open access corridor

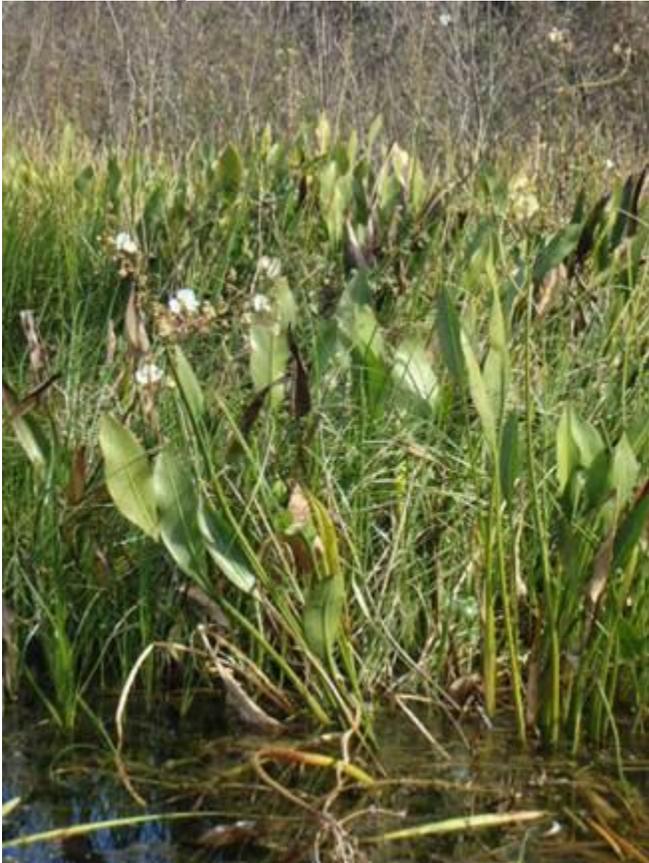
Photo: Duck potato (native) mixed in with burhead sedge (invasive)

Invasive emergent vegetation included: alligatorweed, wild taro, primrose, torpedo grass, burhead sedge, and cattail. No American lotus was present as in previous months. The burhead sedge and torpedo grass was slowly coming back after being hit hard by herbicide treatments. Access corridors throughout the lake are open and navigable.

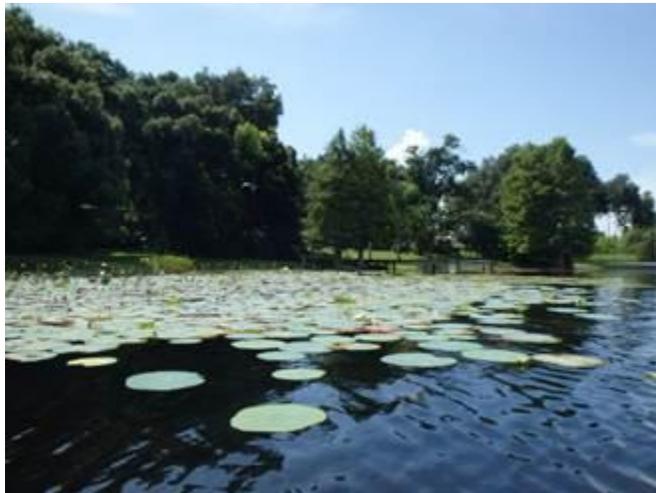
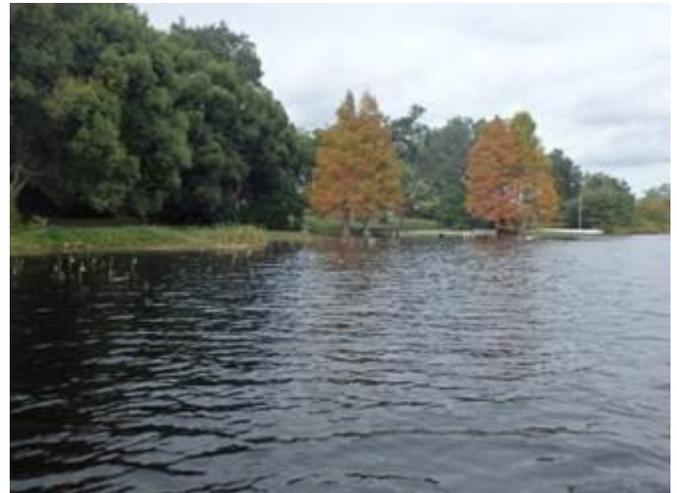
Invasive emergent vegetation includes: alligatorweed, wild taro, primrose, torpedo grass, burhead sedge, and cattail. Since the last inspection, there is a reduction in burhead sedge, American lotus, and torpedo grass. Access corridors throughout the lake are open and navigable.

Photo: Before and after treatment of American lotus.

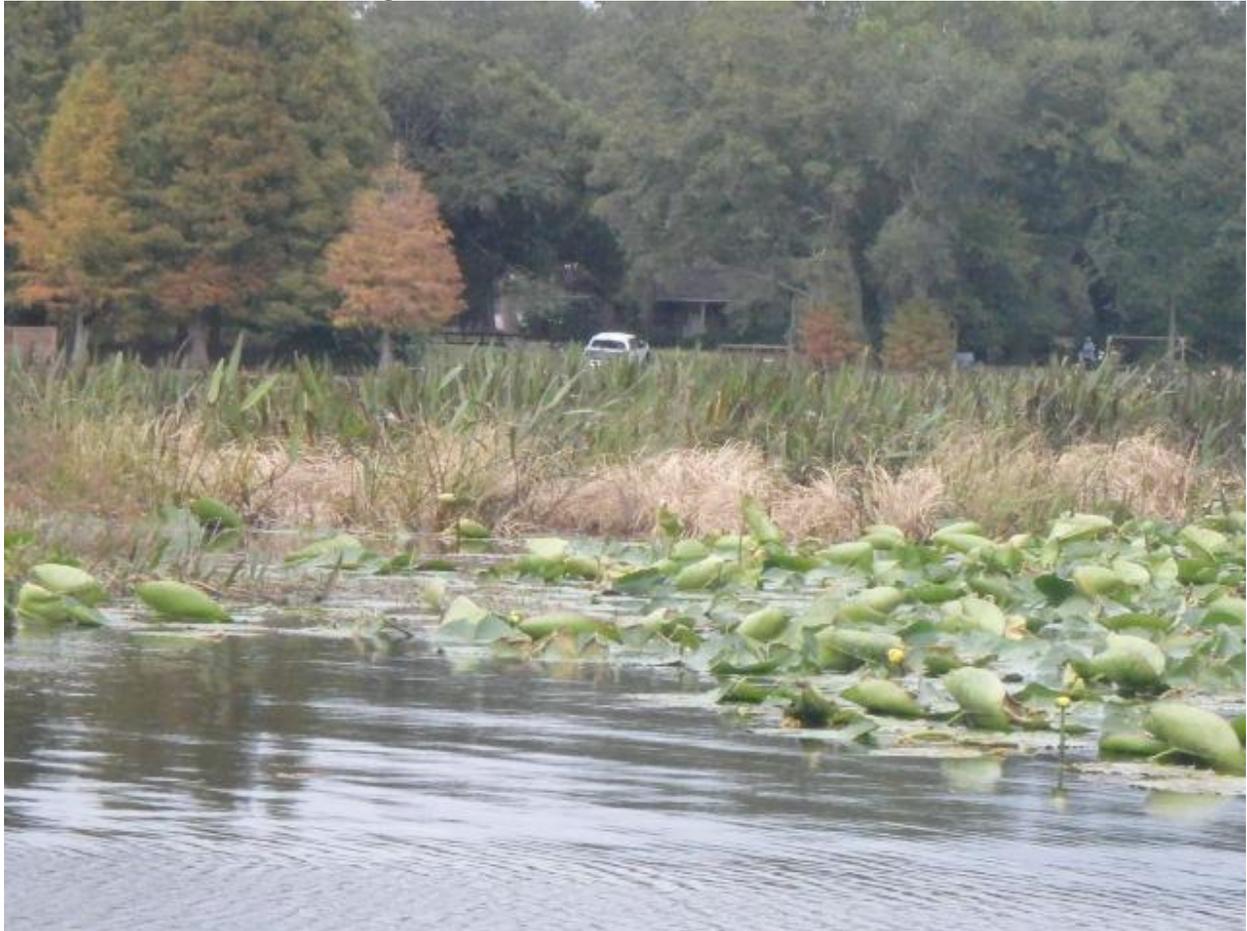
Photo: Treated burhead sedge.
